Investigation and repair of a wellhead leak
on geothermal well BO-2 at Bouillante

Sverrir Þórhallsson

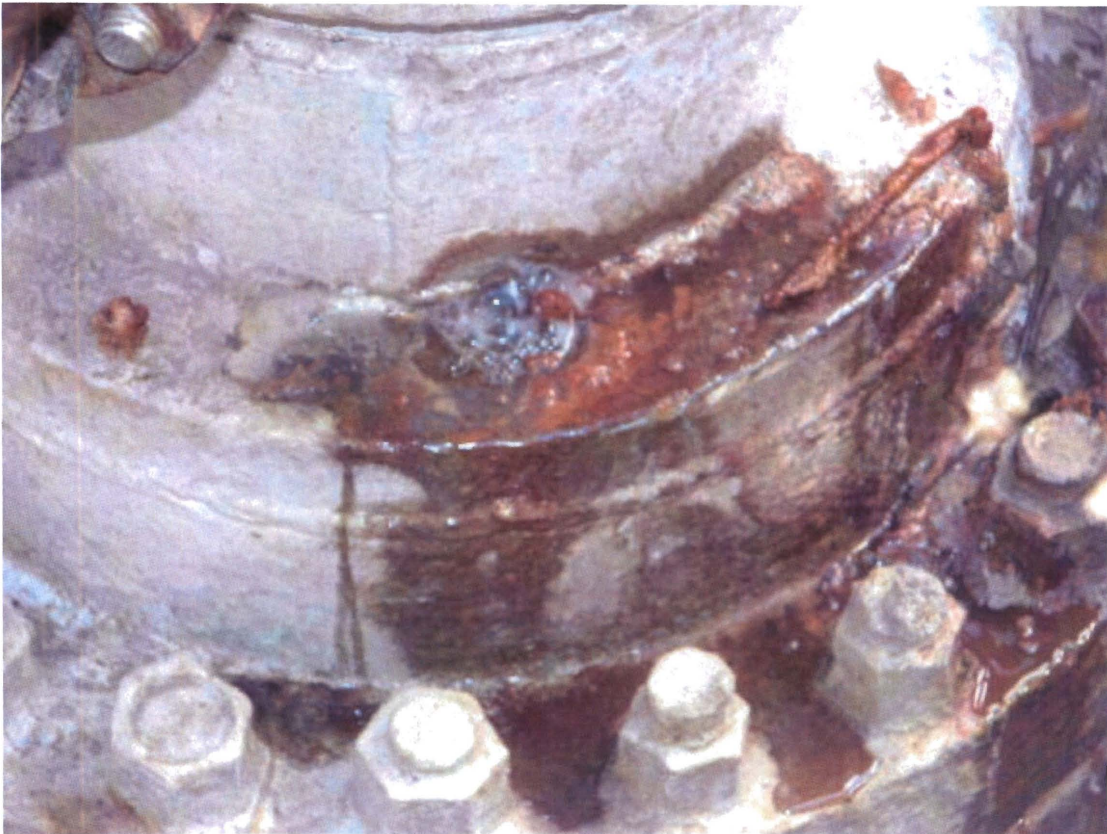
Figure 1. Photograph of the leak on BO-2 wellhead sent to me May 1 (photo H. Correia)

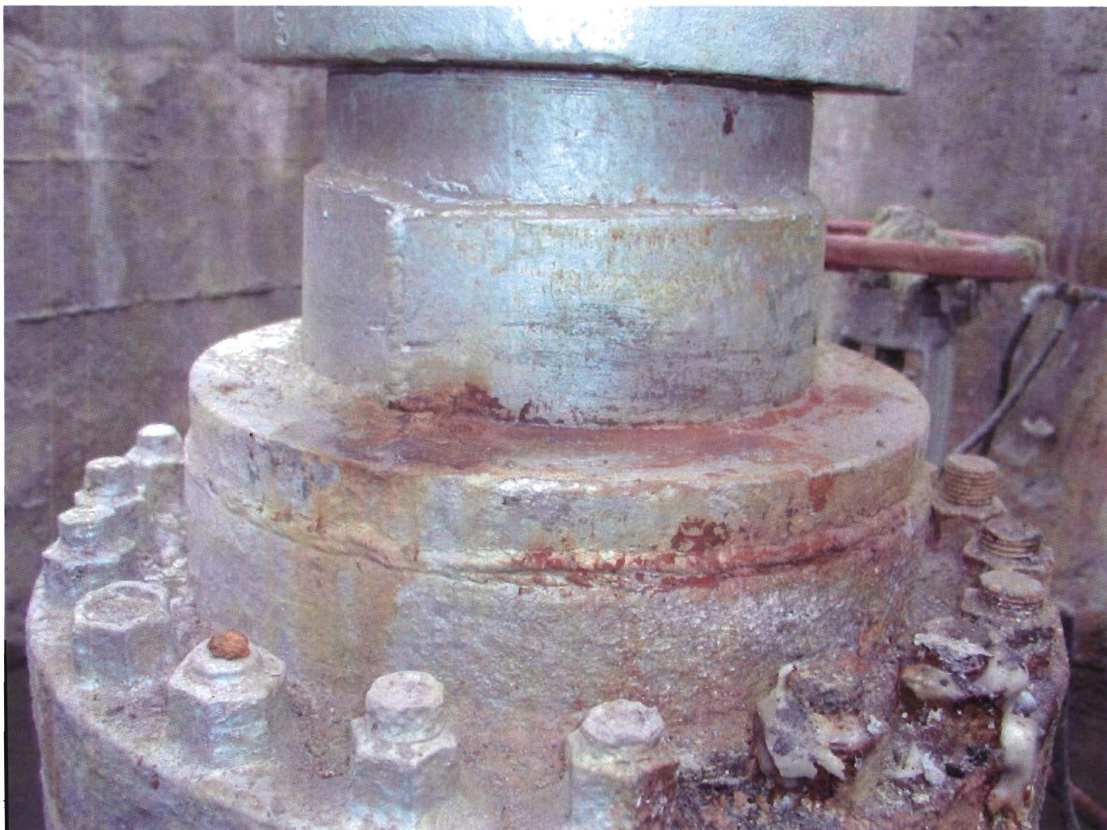
Figure 2. Photograph of leak area on BO-2 when I arrived. The leak had stopped due to self-sealing when the wellhead temperature dropped and thus the annular pressure.

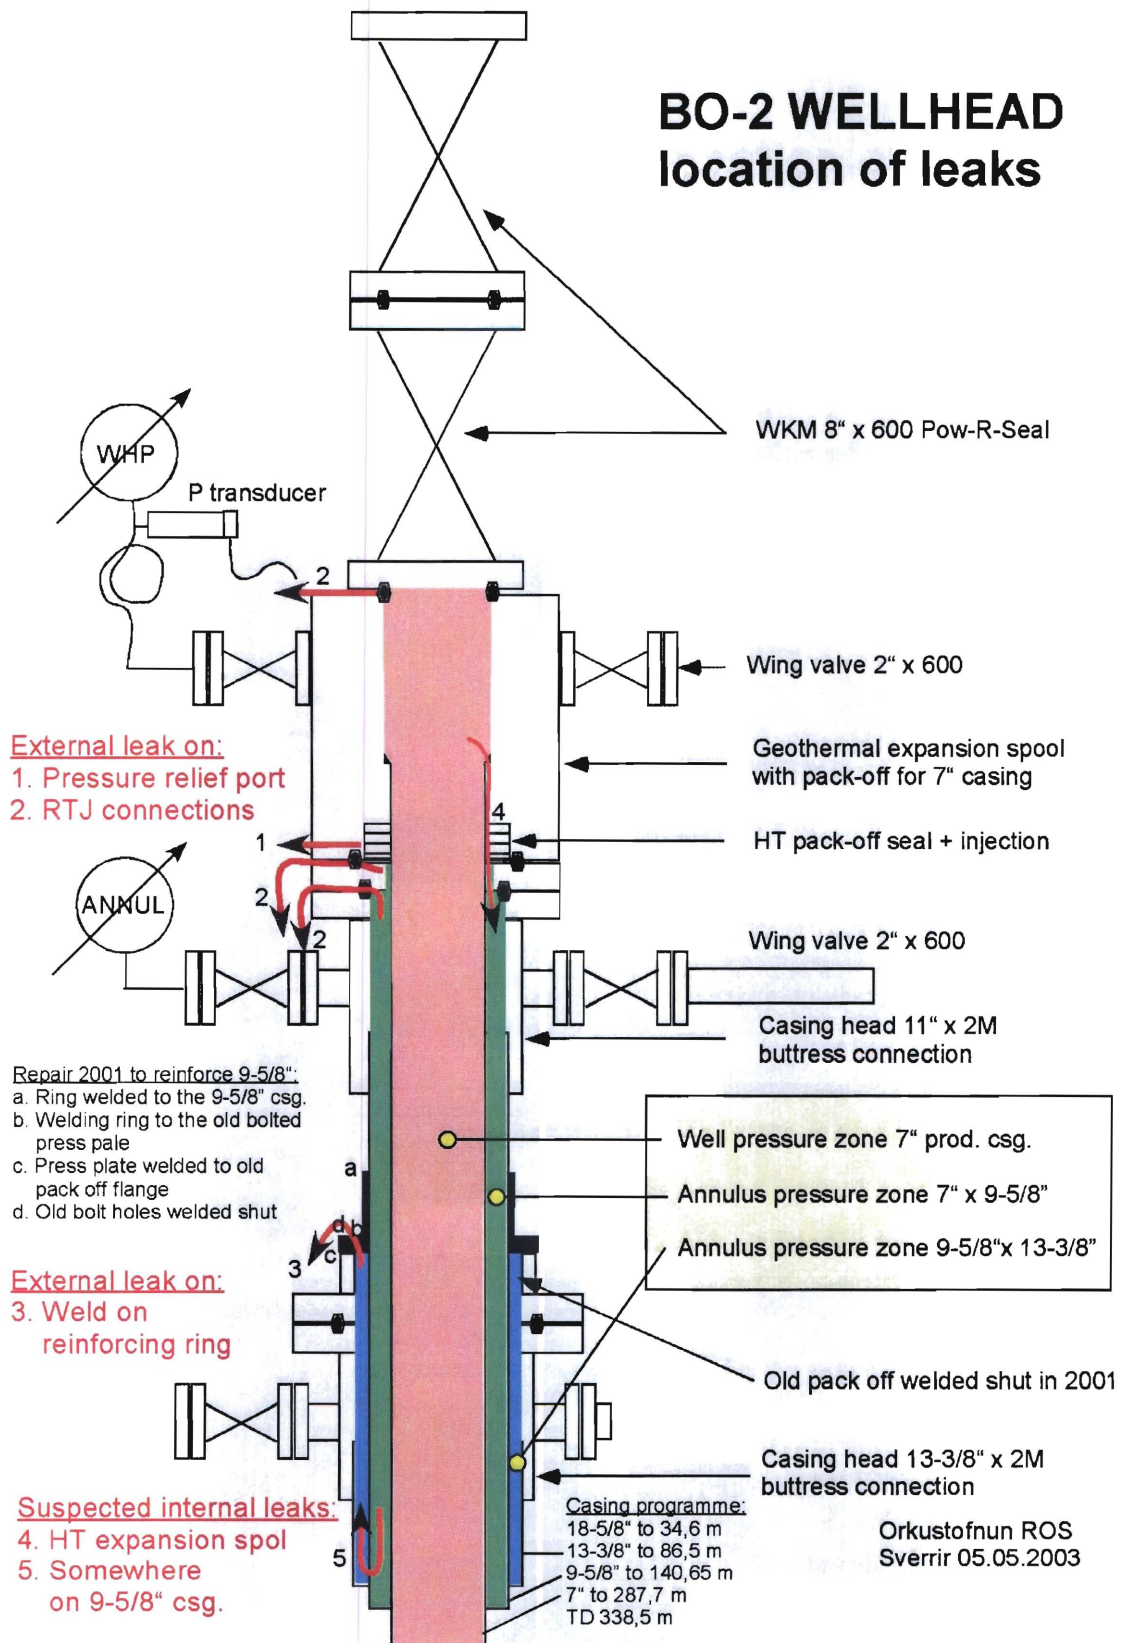
Figure 3. Drawing of BO-2 wellhead showing location of possible leaks and pressure zones.

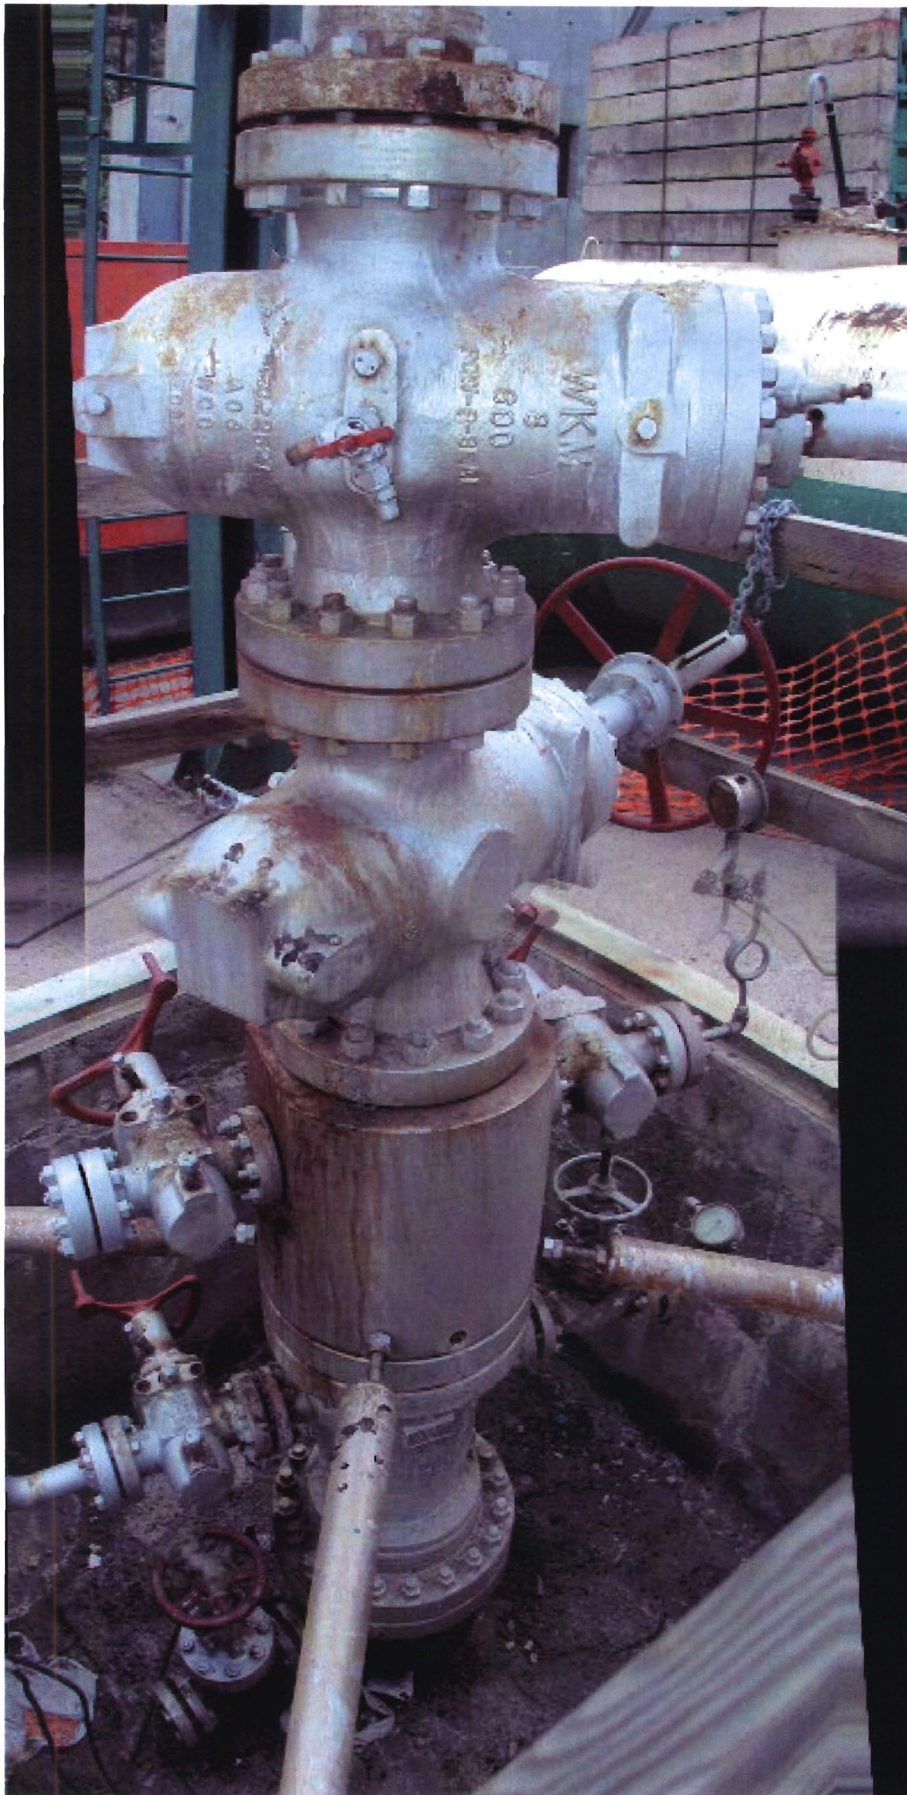
Figure 4. Wellhead of BO-2 in March 2003. The picture is stitched together.

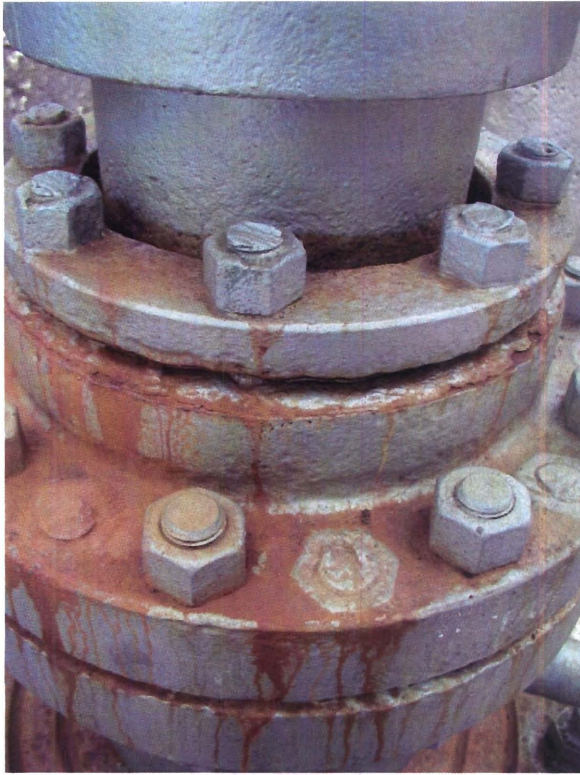
Figure 5. Wellhead of BO-4 showing an identical seal as was welded shut when the reinforcing ring was welded to BO-2 in 2001. Note bolt holes on the seal pressure plate (upper row of bolts) that had to be closed by welding. A pinhole in one such weld caused the present leak on BO-2.

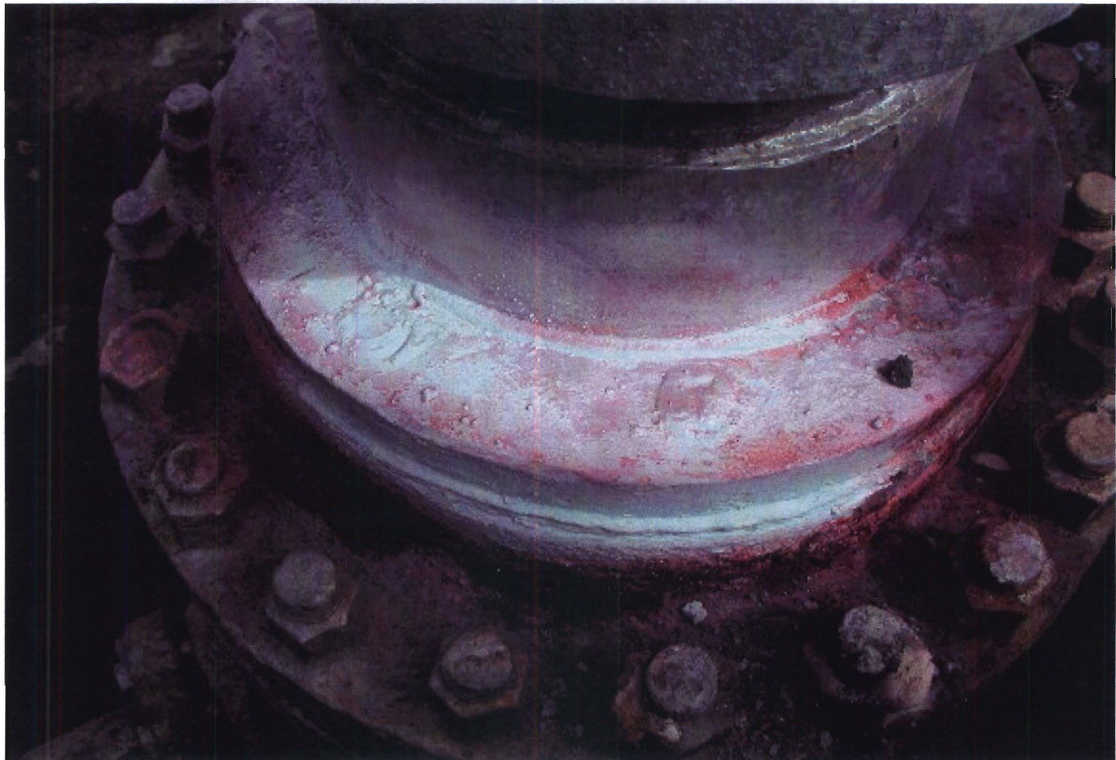
Figure 6. Die penetrant applied to welds on the wellhead of BO-2 where the leak occurred to identify cracks or holes. No welding cracks were detected, but a small pinhole in the weld covering one bolt hole showed up.

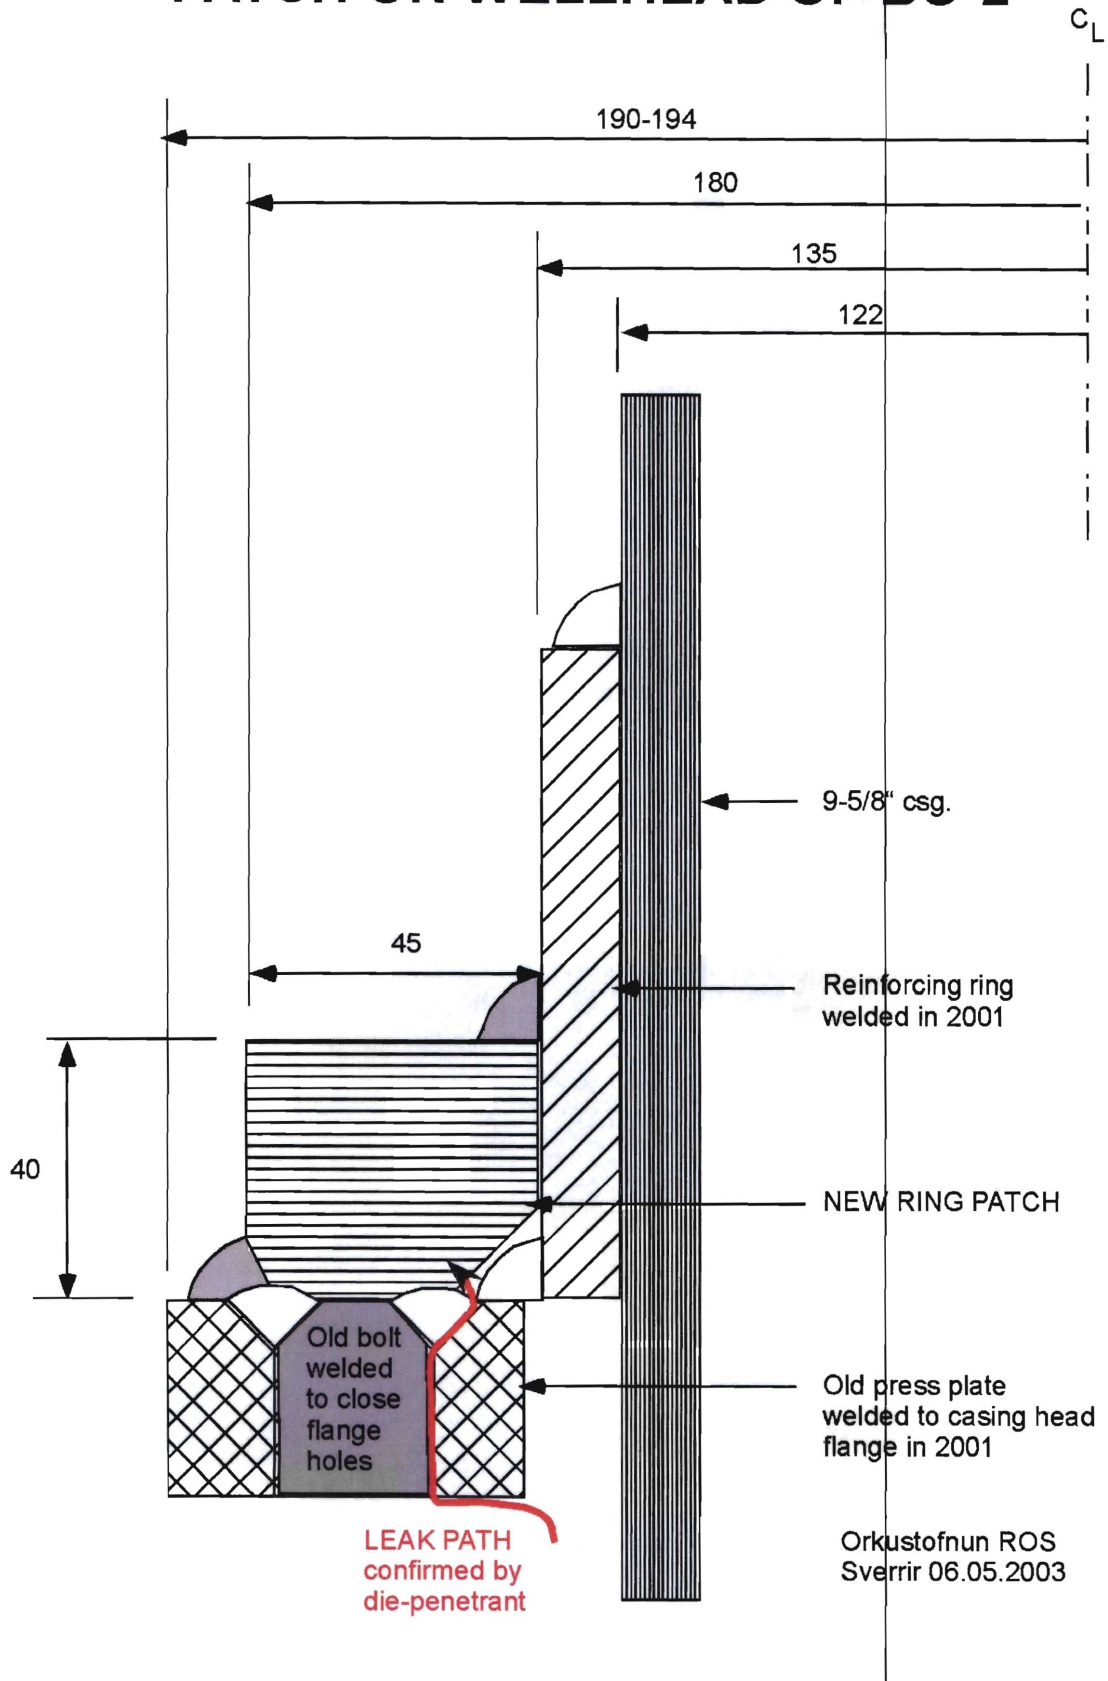
Figure 7. Drawing shows where the leak was – a pinhole defect of a weld. The drawing also shows the design of the ring-patch to cover the leak. The patch was welded in place May 6th.

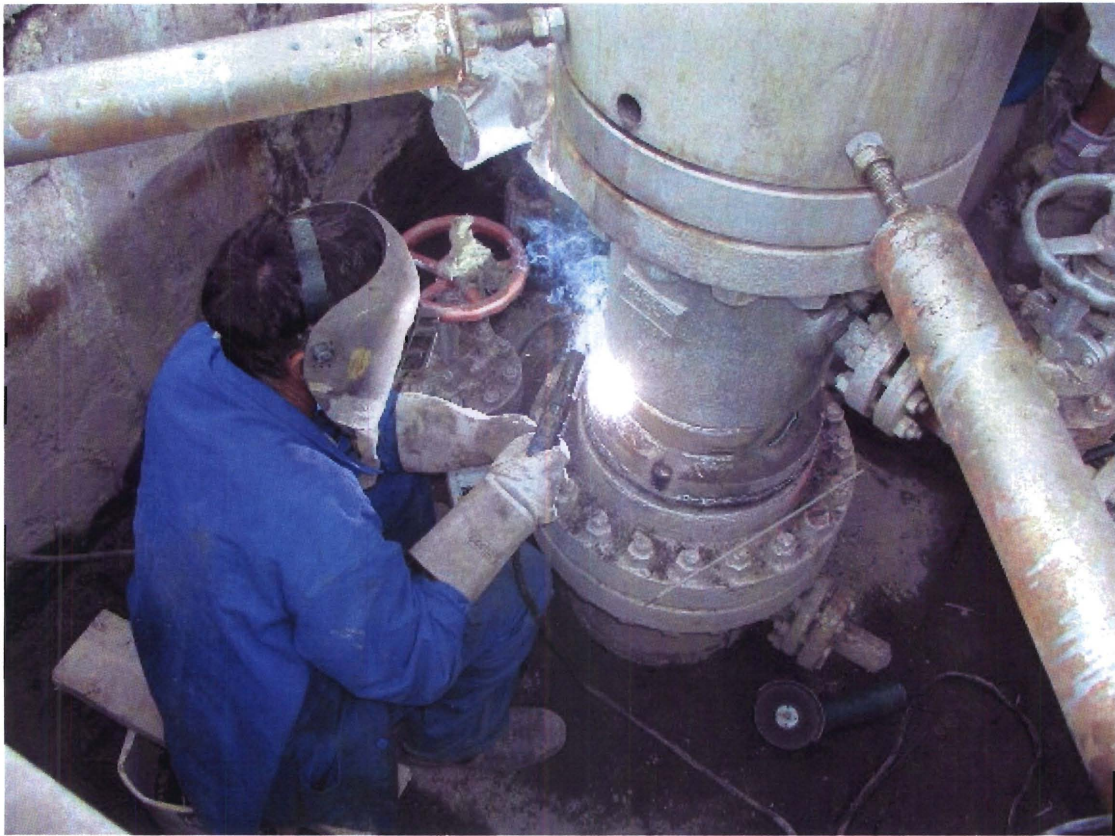
Figure 8. Patch welded in place by a COTUMER welder.

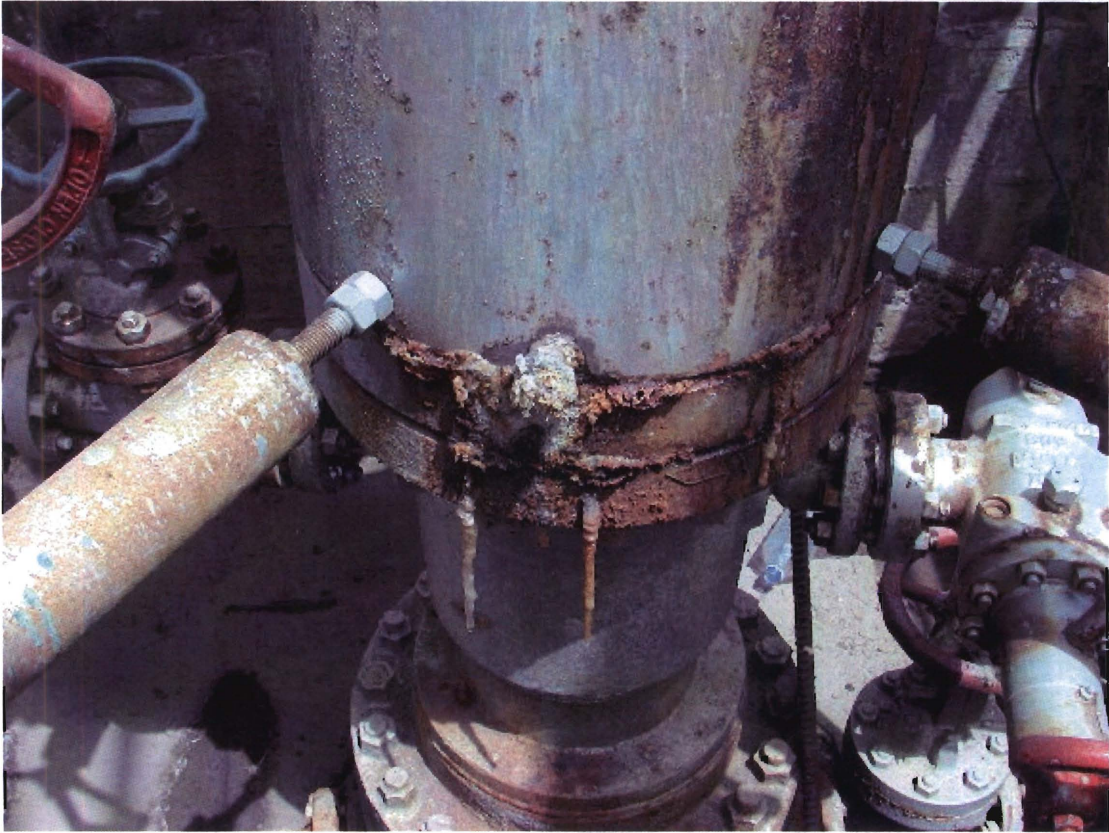
Figure 10. Leak on pressure release tap and between flanges on the expansion spool of BO-2.

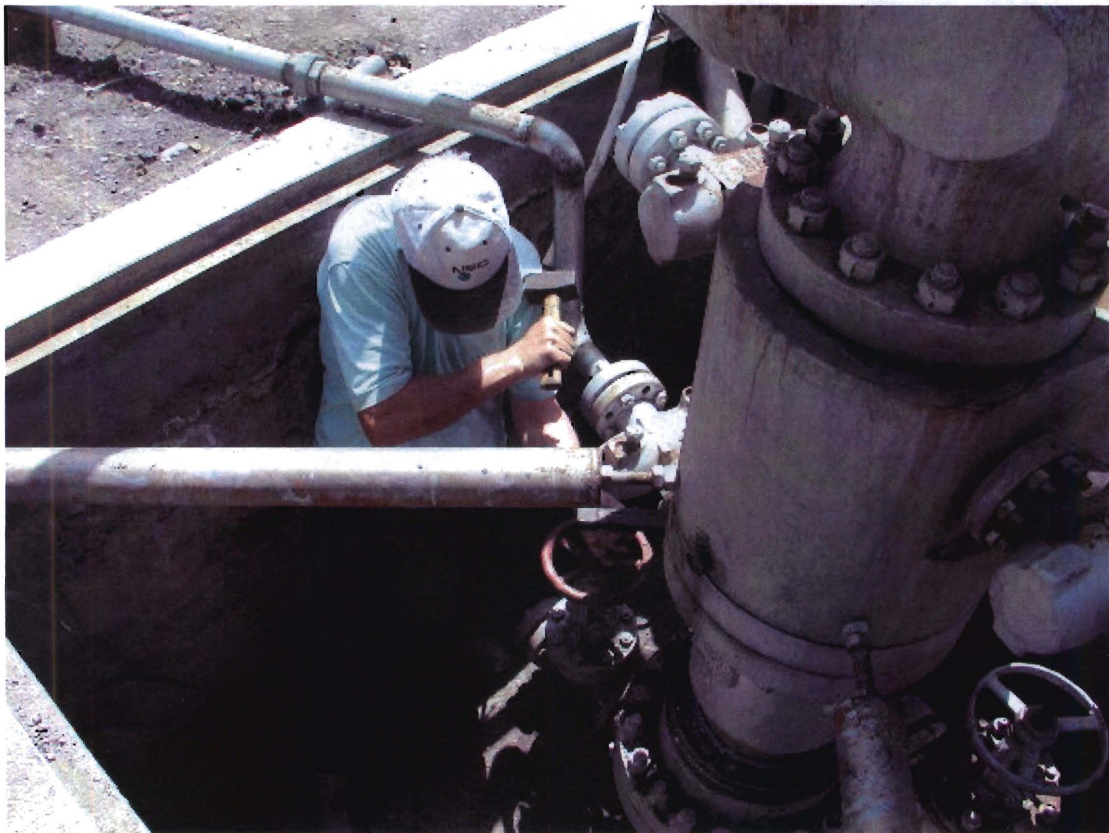
Figure 11. Bolts being tightened on the expansion spool of BO-2 (lower flange) where there was a leak (see Fig. 10).

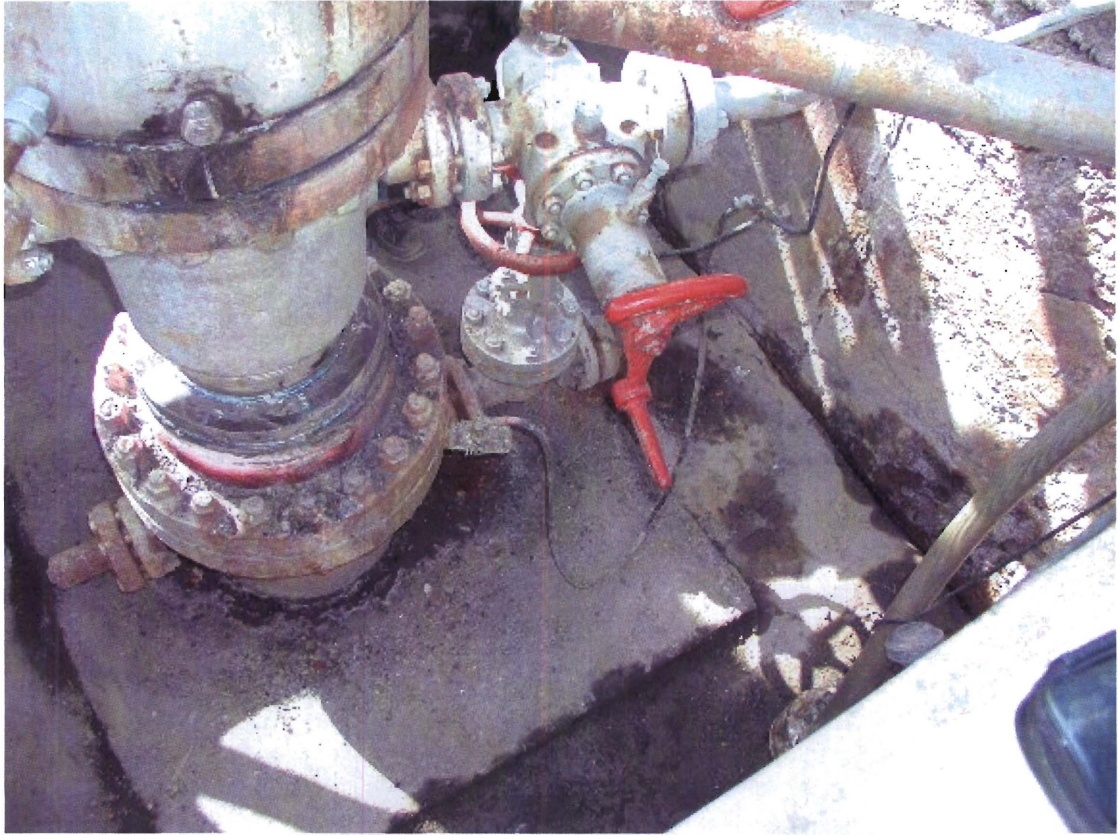
Figure 12. Two bolts were rusted away on the lowest wing valve. Valve since 1970.

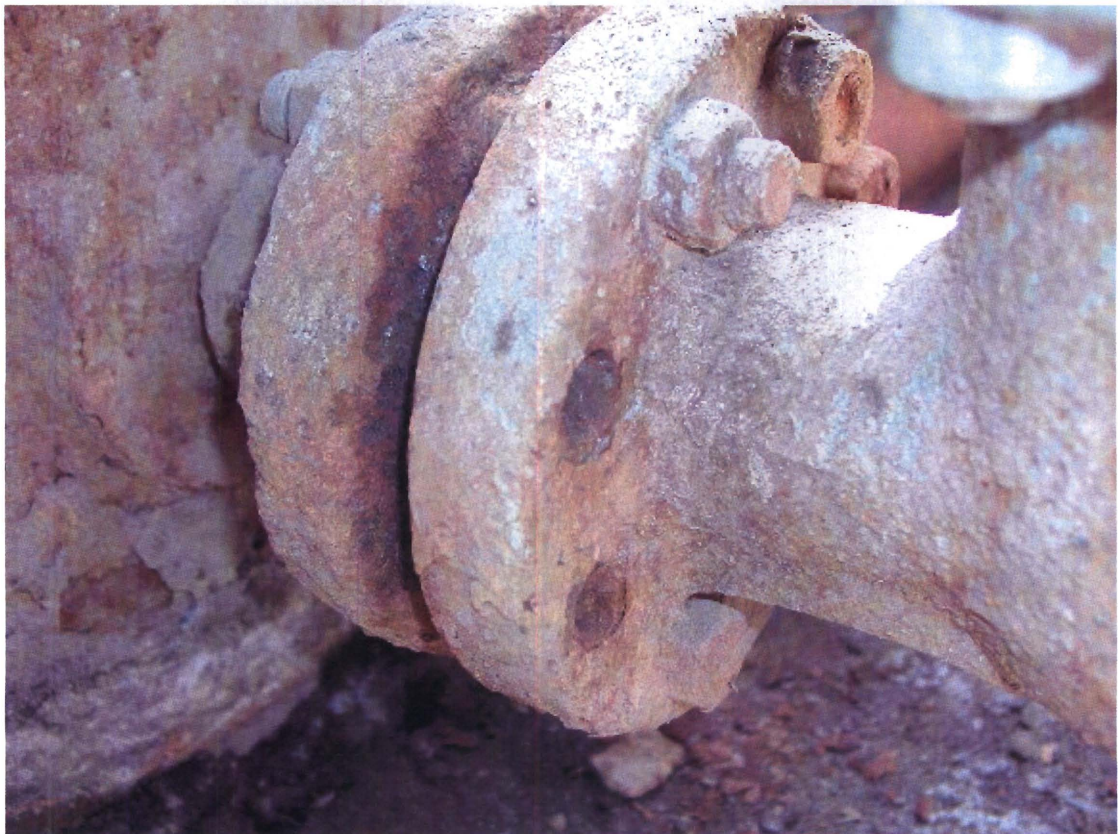
Figure 13. Close-up of bolts missing from flange on 13-3/8" casing head.

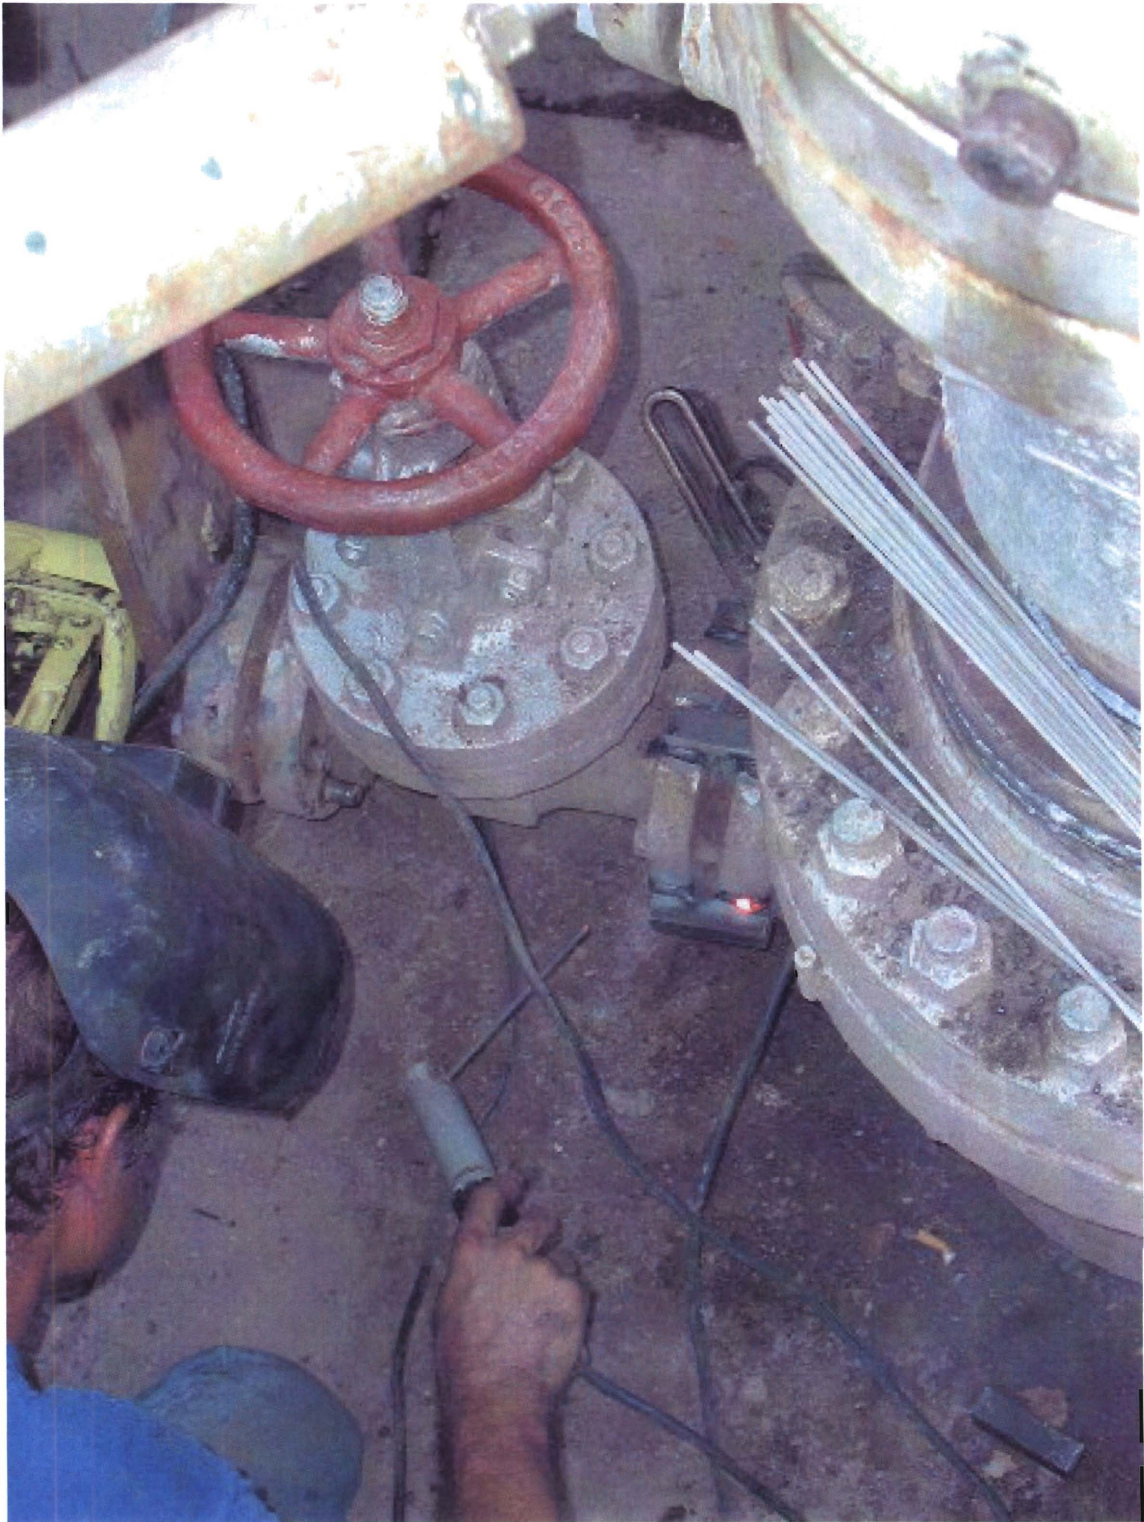
Figure 14. Reinforcing rods 20x20 mm welded over the flange pair of the 3-3/8" wing valve to make up for the loss of the two corroded bolts and suspected weakness of the other stud bolts.

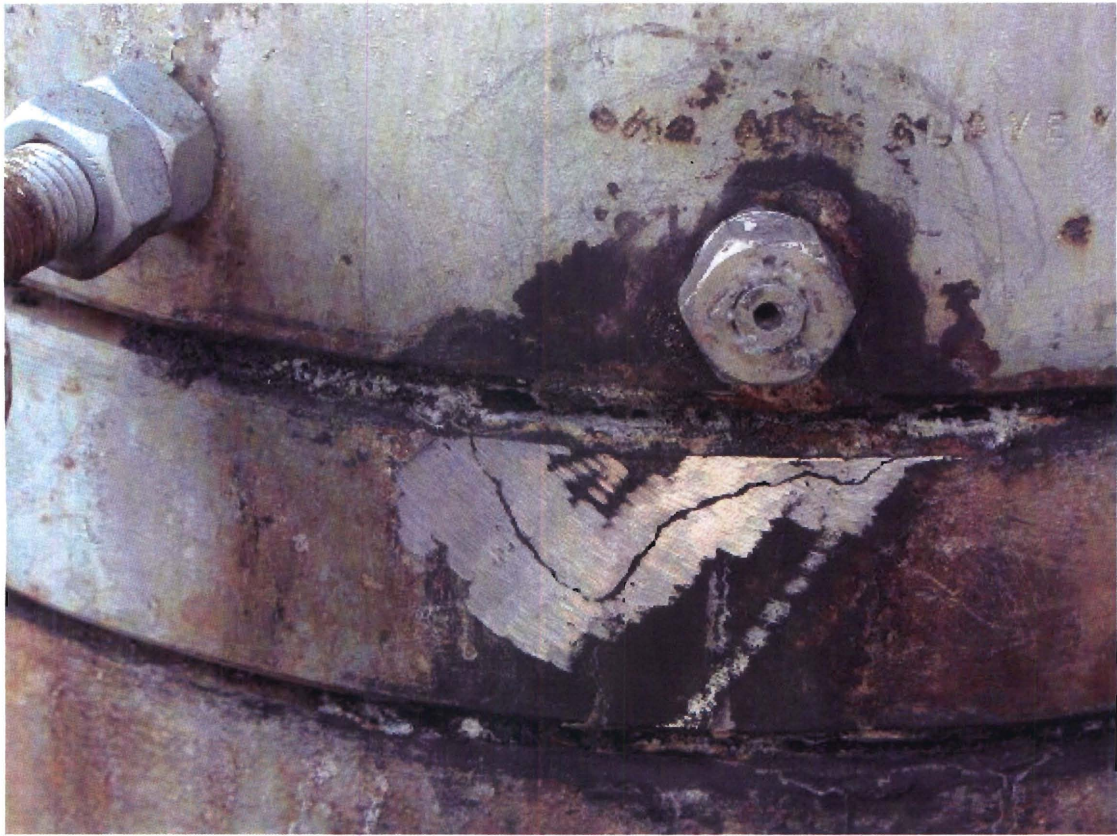
Figure 15. From under the scale deposits on the expansion spool a crack showed up on the flange just below the pressure release port. If it propagates deep it could result in leak.

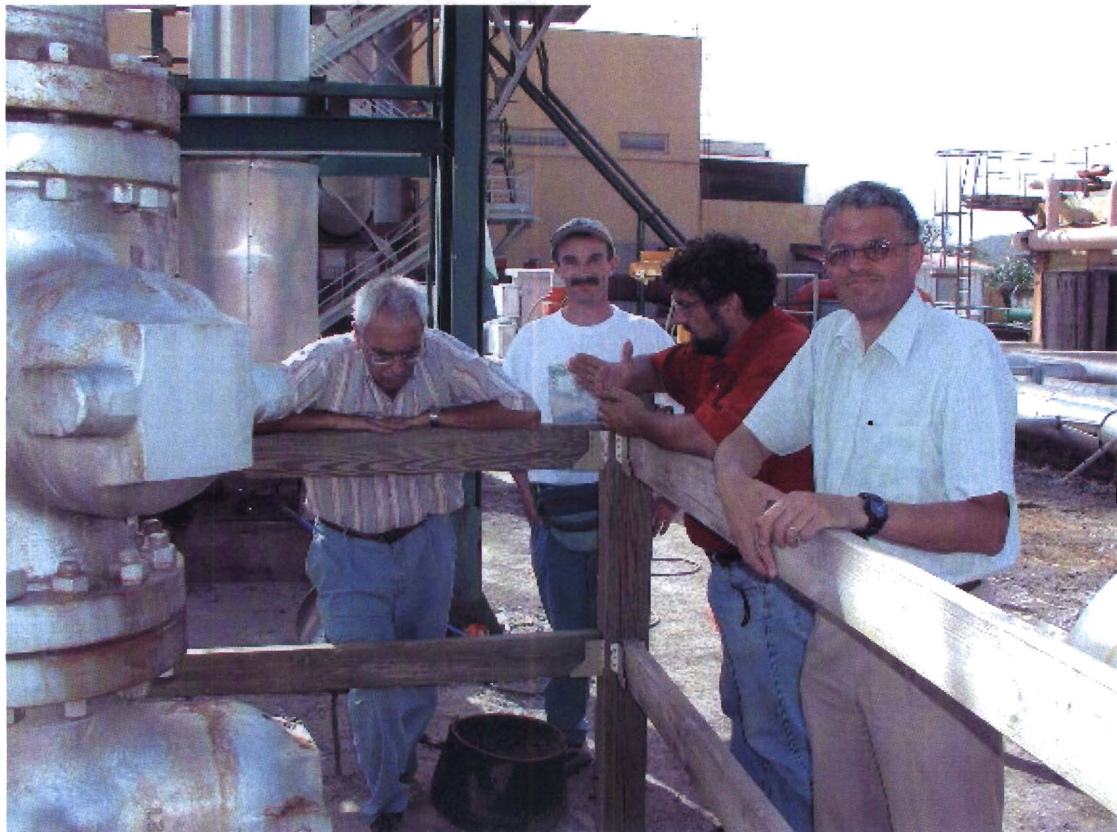
Figure 16. Discussions on what to do....
